1. AGENCY USE ONLY (Leave blank)		2. REPORT DATE June 1994		3. REPORT TYPE AND DATES COVERED Final Report
4. TITLE AND SUBTITLE Metallurgical Examination of Failed T-158 Cast Austempered Ductile Iron (CADI) Track Shoes			5. FUNDING NUMBERS

6. AUTHOR(S) V. Champagne, M. Pepi, B. Pothier, D. J. Snoha, G. Wechsler, and M. G. H. Wells				
7. PERFORMING ORGANIZATION NAME(S) AND ADDRESS(ES) U.S. Army Research Laboratory Watertown, MA 02172-0001 ATTN: AMSRL-MA-CB			8. PERFORMING ORGANIZATION REPORT NUMBER  ARL-TR-451

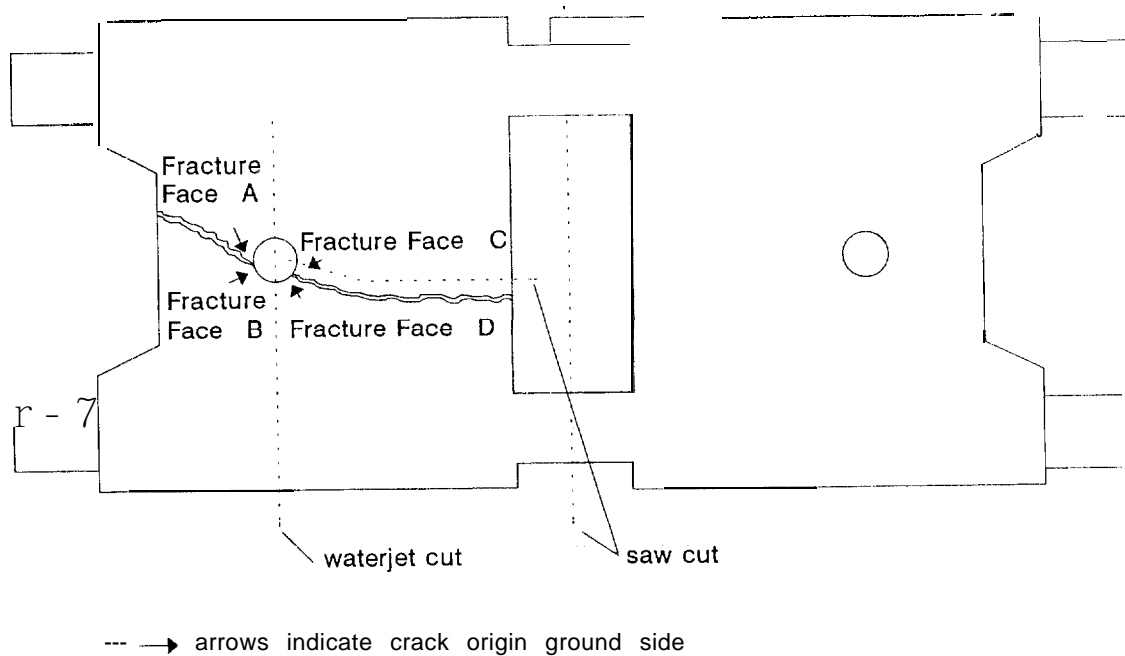
FIGURE 8 Schematic showing method used to section the fracture surfaces apart from track shoe #L30.

Figure 7 shows the failed half of the track shoe. The location of the crack was on the ground side. The track shoe was sectioned in order to examine the fracture surfaces, as shown schematically in Figure 8. These fracture surfaces were labelled A, B, C and D for identification purposes. Each fracture surface was covered with a vast amount of corrosion products, indicating a prolonged exposure to the environment. Figure 9 shows fracture faces A and B respectively. Fracture face C is shown in Figure 10, while fracture face D is shown in Figure 11. Although the fracture faces were covered with corrosion, fractographic features were still discernable. The chevron patterns and river markings of each fracture surface indicated the fracture initiated at the bolt hole (ground side). Figure 12 shows a magnified view of the crack through the bolt hole region (ground side). This hole is utilized to attach the ice cleat to the track shoe. Figure 13 shows a magnified view of the underside of the cracked bolt hole region (wheel side). This hole was examined, in order to reveal anomalies which may have contributed to crack initiation. It was noted that the top 1/16 inch of this hole contained what appeared to be a start of a thread (Figure 12). The TACOM drawing for a forged component does not require this bolt hole to contain threads or a chamfer, as it is solely a through-hole. Figure 14 shows the comparison between the bolt hole of track shoe #R6 and that of track shoe #L30. The bolt hole of track shoe #R6 contained no such markings. In addition, significant wear was noted on the underside of the hole, most likely the result of a washer or bolt head. Magnetic particle inspection was performed on this hole to reveal possible evidence of cracking. Figure 15 is a blacklight photograph showing the wear, as well as a crack (as denoted by the arrow). Figure 16 is a photomicrograph of the fracture origin, as noted on Fracture Face B. Figure 17 shows an enlargement of the crack origin, as noted on Fracture Face D.

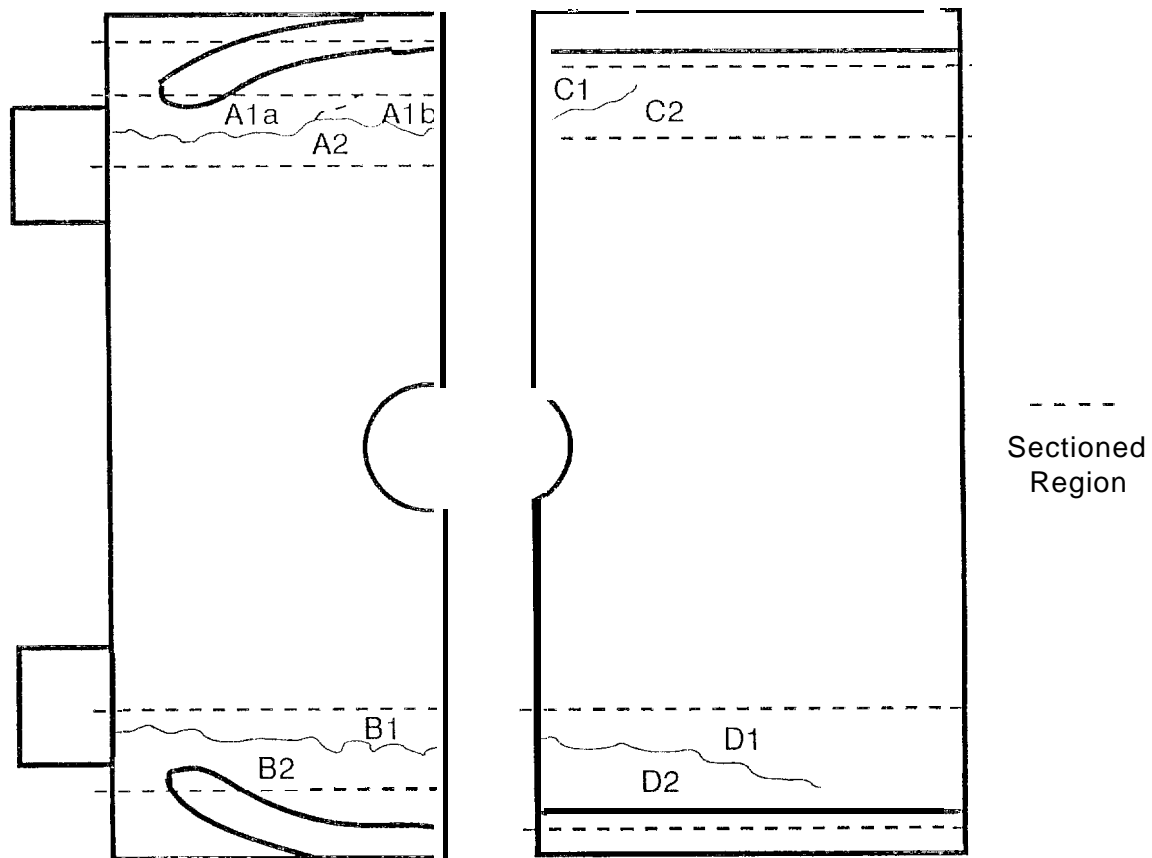
FIGURE 20 Schematic showing method of sectioning for the fracture surfaces of track shoe #R6.

Figure 18 shows the failed half of the track shoe. The crack initiation site occurred on the ground side of each binocular tube. Figure 19 shows an end view of the cracking. Figure 20 schematically illustrates the method of sectioning for the second failed track shoe. The fracture faces were labelled A, B, C and D. Segment A1 broke into two pieces upon sectioning, and was labelled as A1a and A1b. As with track shoe #L30, the fracture surfaces were heavily corroded, but some fractographic features were still discernible. Figure 21 is a montage showing fracture face A and fracture face C. The chevron pattern and river markings indicated the fracture initiated in the region designated by the arrow. This region was on the ground side of the track shoe. Similarly, Figure 22 is a montage of fracture face B and D. Again, the chevron pattern and river markings revealed the fracture origin to be the location designated by the arrow. Figures 23 and 24 are magnified views of the fracture origins (from fracture face A and B, respectively). No obvious surface anomalies were noted at either of the fracture origin sites.

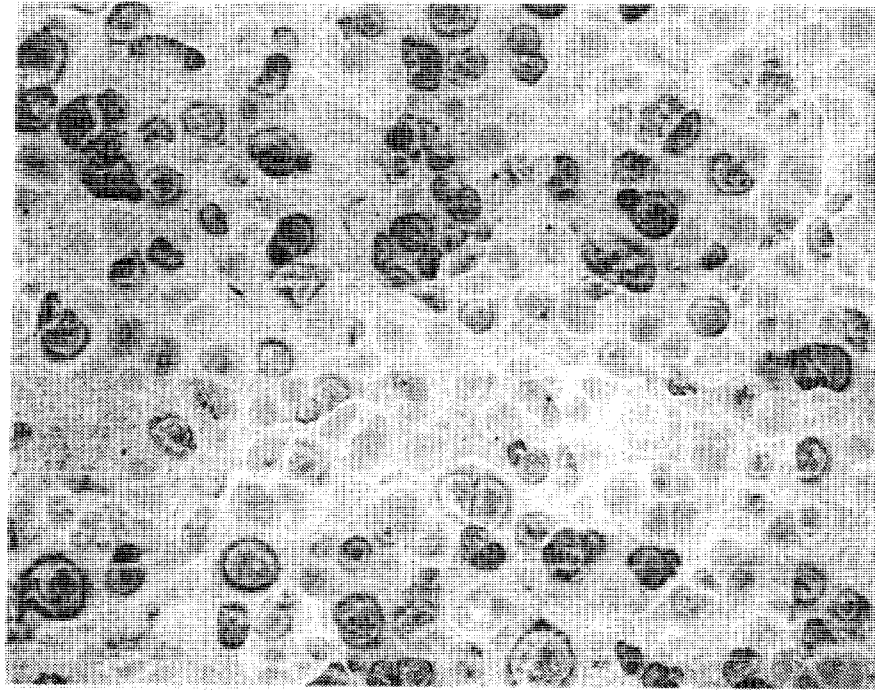
FIGURE 29 Low magnification SEM photograph of the fracture surface of a laboratory tested impact specimen. Mag. 150x.

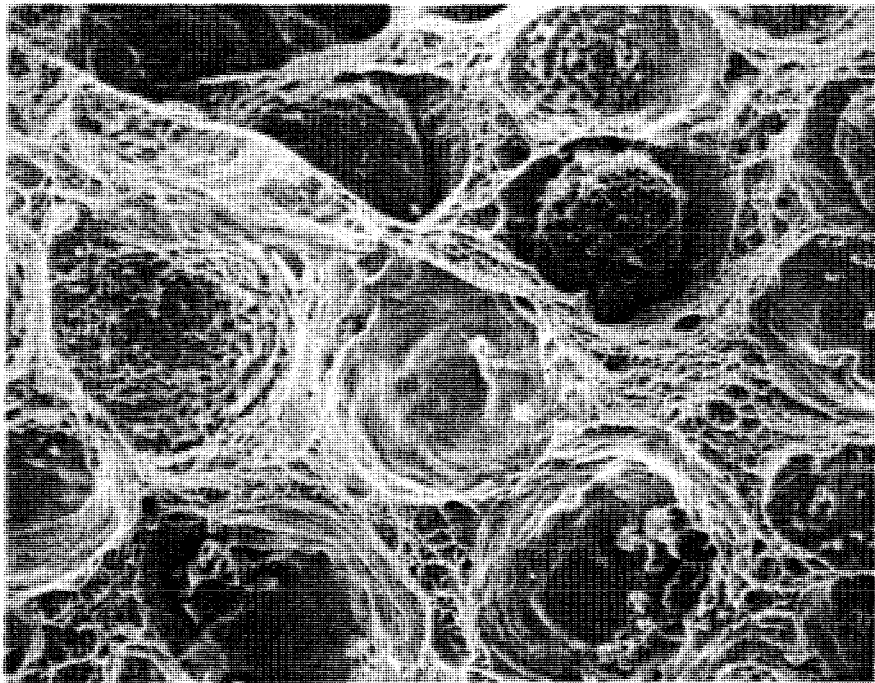
For comparative purposes, the fracture surfaces of laboratory tested tensile and impact specimens were examined utilizing the SEM. Both the tensile and impact fracture surfaces were similar. Figure 29 shows the fracture surface of an impact specimen at low magnification. Note the graphite spheroids, and the pits left by the pulled-out spheroids. Figure 30 shows this region at higher magnification. Note the ductile dimples surrounding the graphite spheroids.

FIGURE 30 High magnification SEM photograph of the fracture surface of a laboratory tested impact specimen. Note the ductile dimples, similar to those found on the fracture surface of the failed track shoes. Mag. 800x.

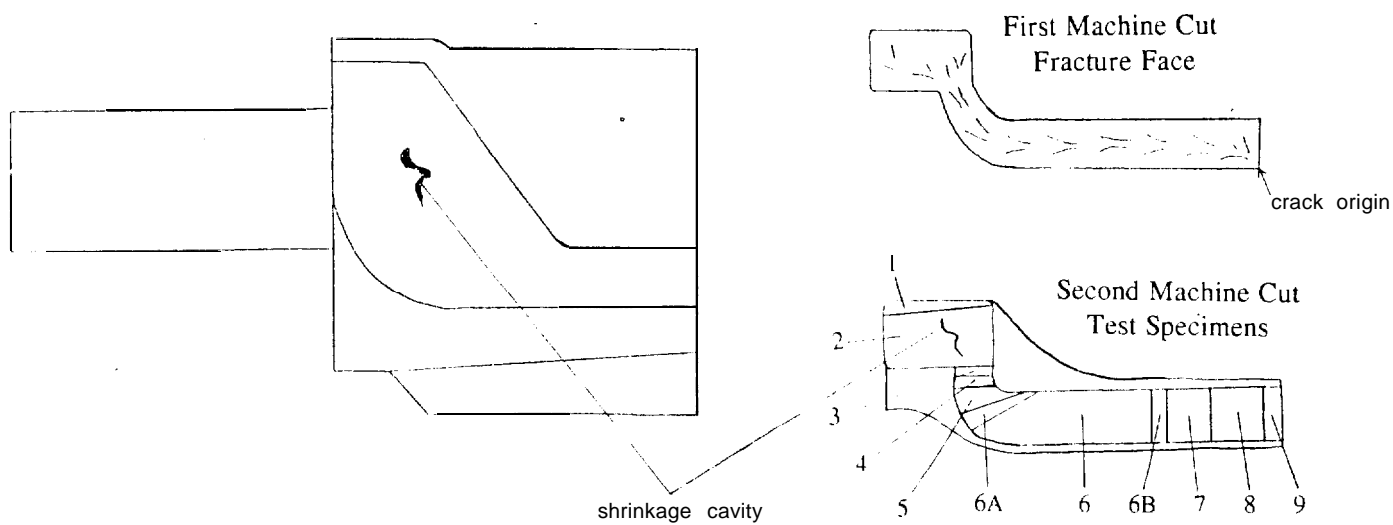
FIGURE 3 1 Schematic of sectioning diagram for metallographic and retained austenite samples from track shoe #L30. Similar specimens were sectioned from track shoe #R6.

Regions representing "thin" and "thick" areas of the casting were sectioned from each of the failed track shoes and prepared for metallographic examination, as shown schematically in Figure 31. This diagram shows a total of eleven samples which were sectioned from a portion of failed track shoe #L30 for metallographic samples and retained austenite measurement samples. Similar specimens were sectioned from track shoe #R6. Examination in the as-polished condition and at low magnification (12.5x) revealed a very large shrinkage cavity within a thick region from track shoe #L30, as shown in Figure 32. The graphite spheroids were shown to be evenly distributed within the matrix (Figure 33). The nodules differ in size significantly which suggests that some may have formed early in the casting process while other formed later by post inoculation. However, the difference in sizes could also be due to a "slicing effect", in which different portions of the randomly distributed nodules were sectioned. In addition, some flaked nodules were noted. In excess, these irregularly shaped nodules are undesirable, since the larger surface to volume ratio raises the notch sensitivity and lowers the fatigue and impact resistance of the casting. Figure 33 was used to classify the graphite size per ASTM A 247 [3], *Method for Evaluating the Microstructure of Graphite in Iron Castings*. The average graphite dimension measured was within the 5-6 size class. The average nodule count measured from three samples of each track shoe was approximately 132 per sq. mm. nodules, which is considered acceptable, although slightly less than optimal for Grade 150/100/7 CAD1.

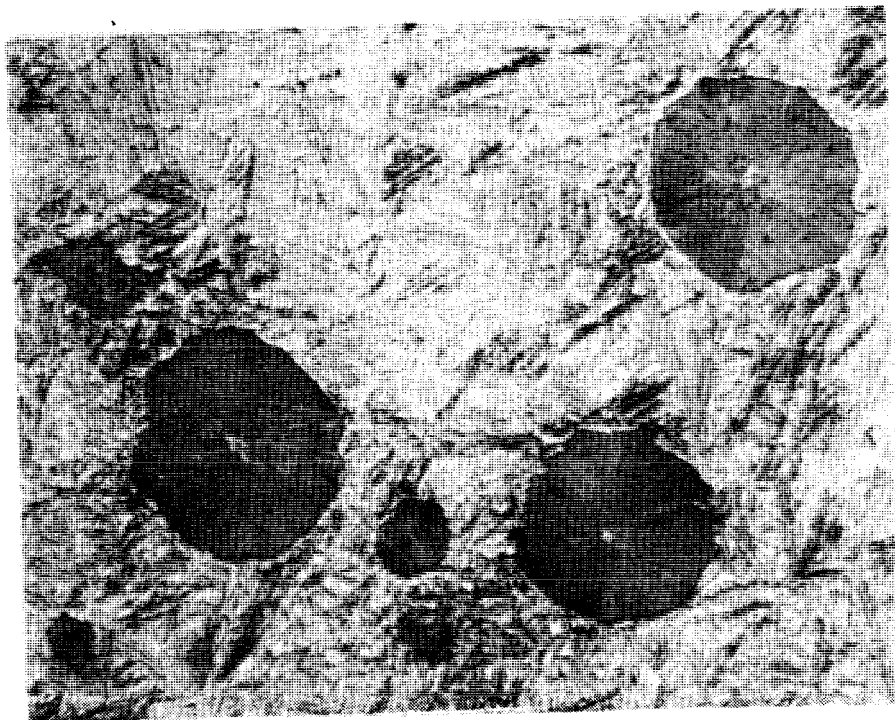
FIGURE 34 Typical microstructure of track shoe CAD1 with the application of a 4% Picral 'etchant. Mag. 500x.
